HARFORD COUNTY DPW

UPPER FARNANDIS SMALL WATERSHED ASSESSMENT REPORT

APRIL 02, 2018

HARFORD COUNTY DEPARTMENT OF
PUBLIC WORKS

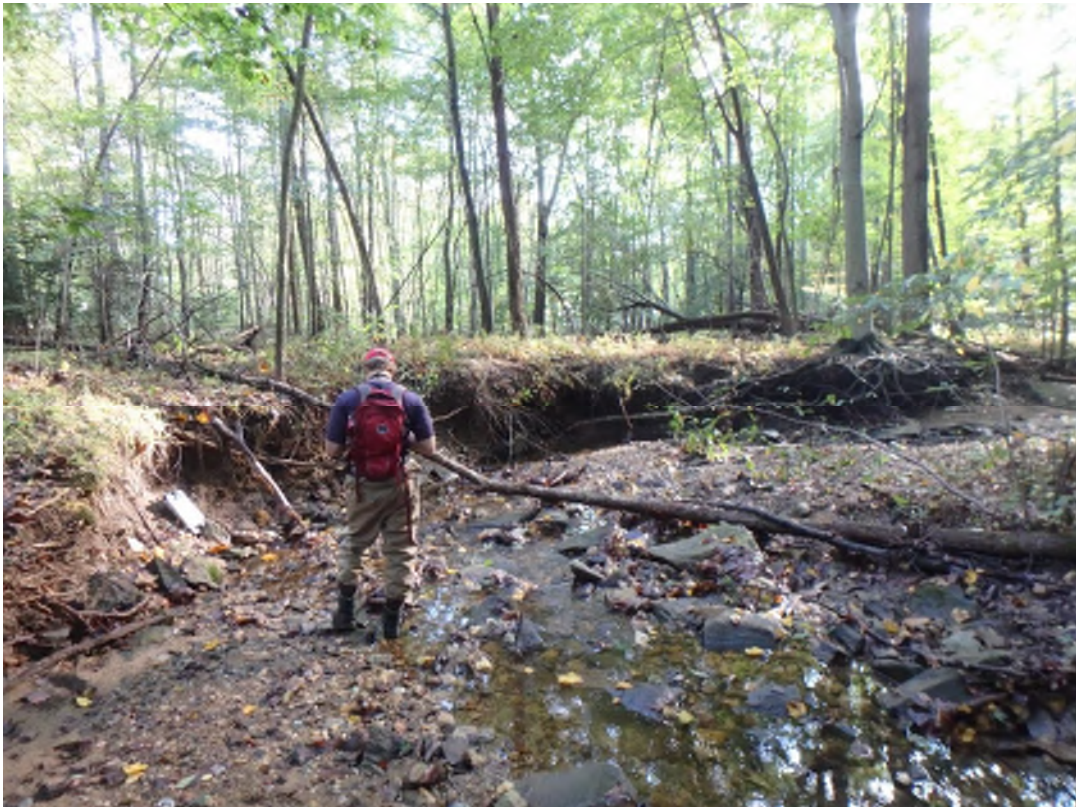
Figure 16: Undercut bank in tributary 1 upstream of outfall 5 (Figure 17).

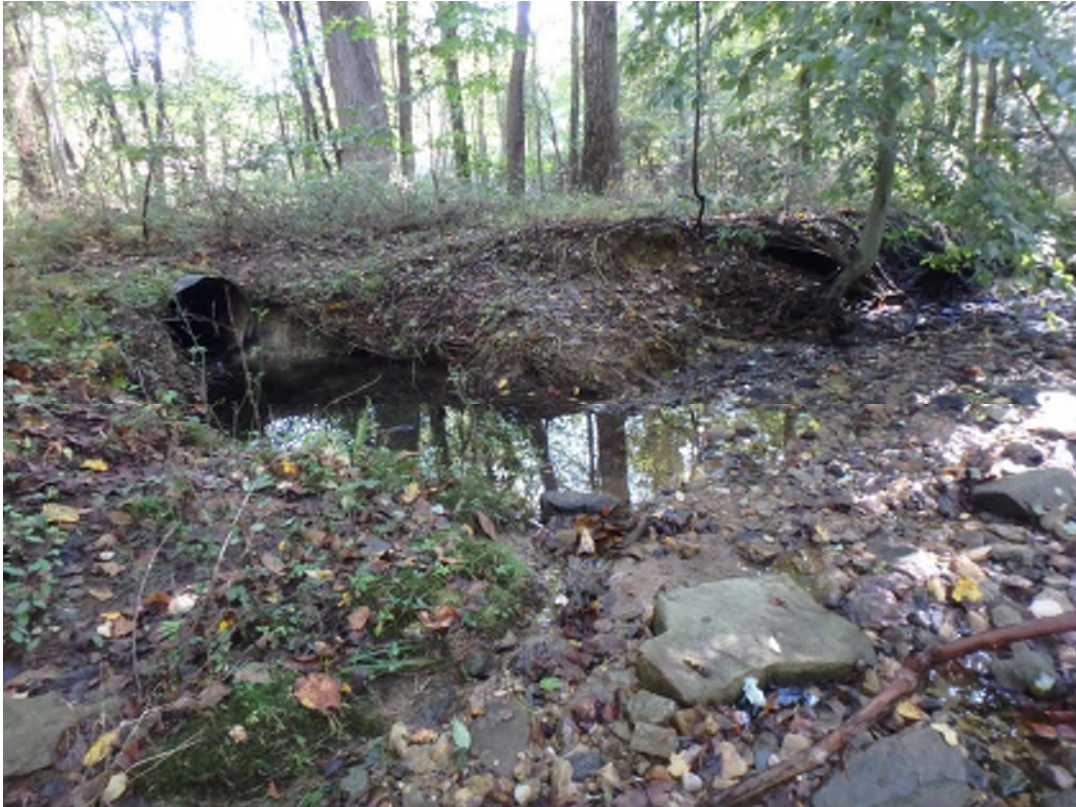
Figure 17: Outfall 5 is a 36-inch metal pipe conveying flow to left bank of tributary 1. Outfall is approximately 13 feet from tributary 1.

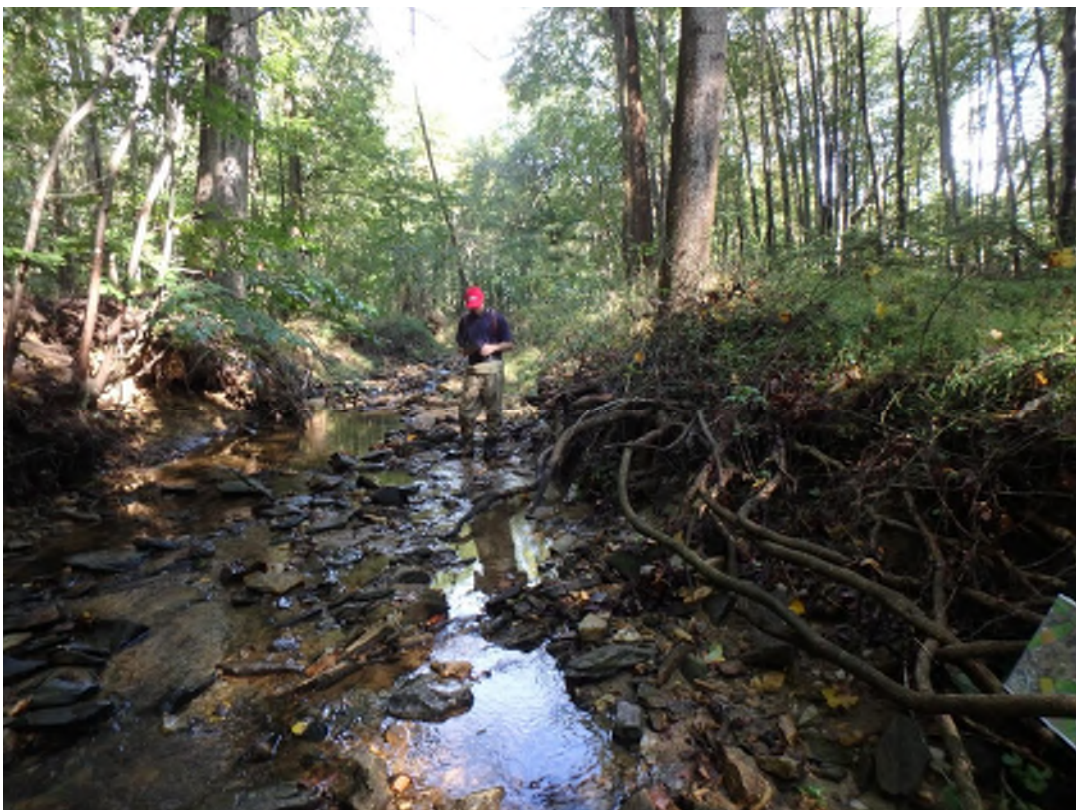
Figure 18: Erosion upstream of outfall 6 in tributary 1.

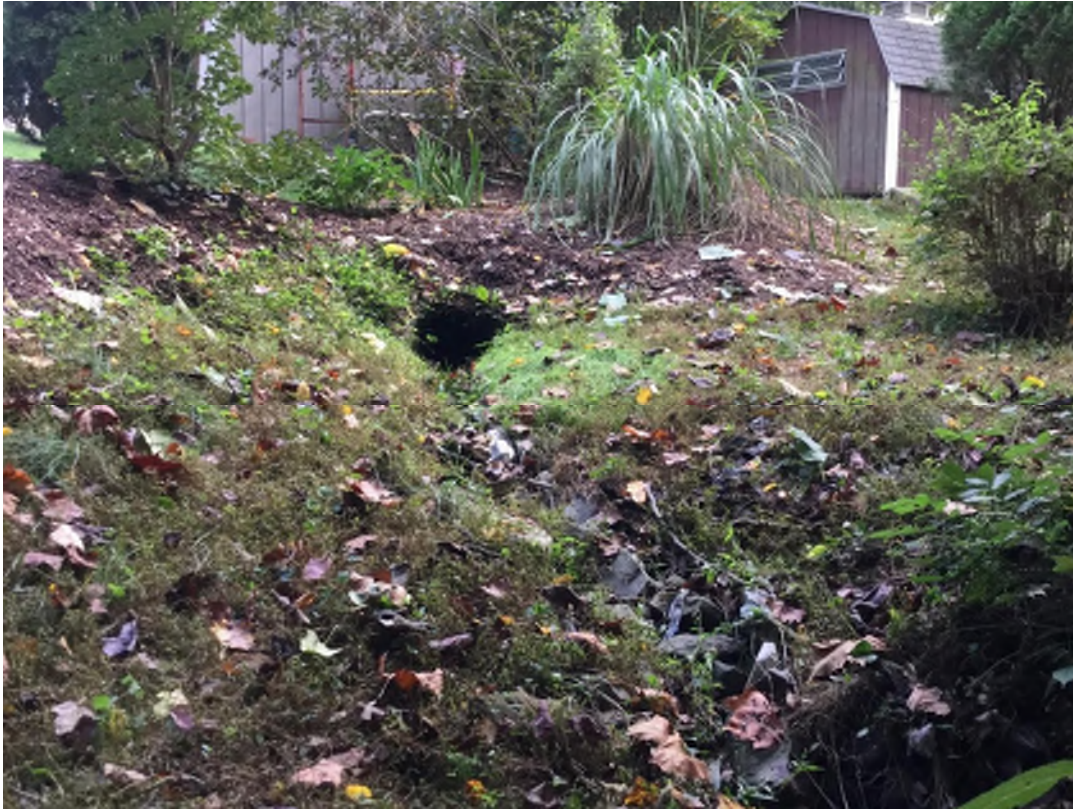
Figure 19: Outfall 6 is a 15-inch metal pipe conveying flow to left bank of tributary 1. Outfall is approximately 15 feet from tributary 1 and has 15 feet of riprap outfall protection.

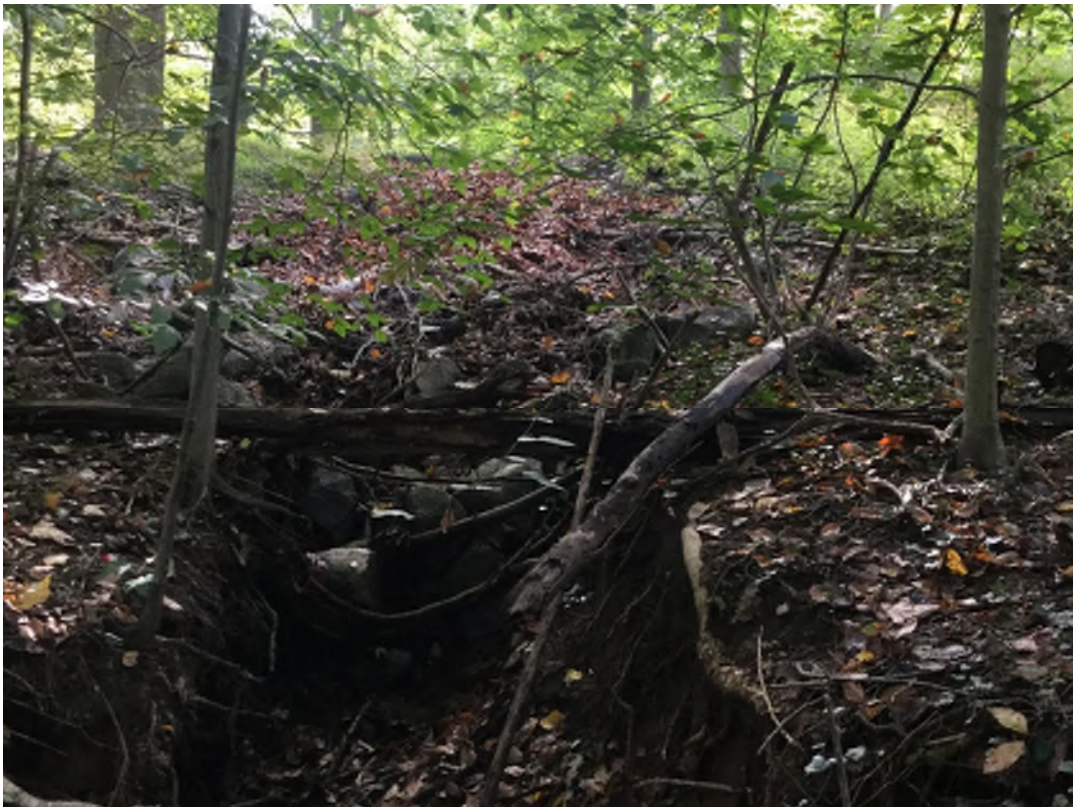
Figure 22: Inflow from roadway to start of tributary 4. Bank erosion present at location of inflow.

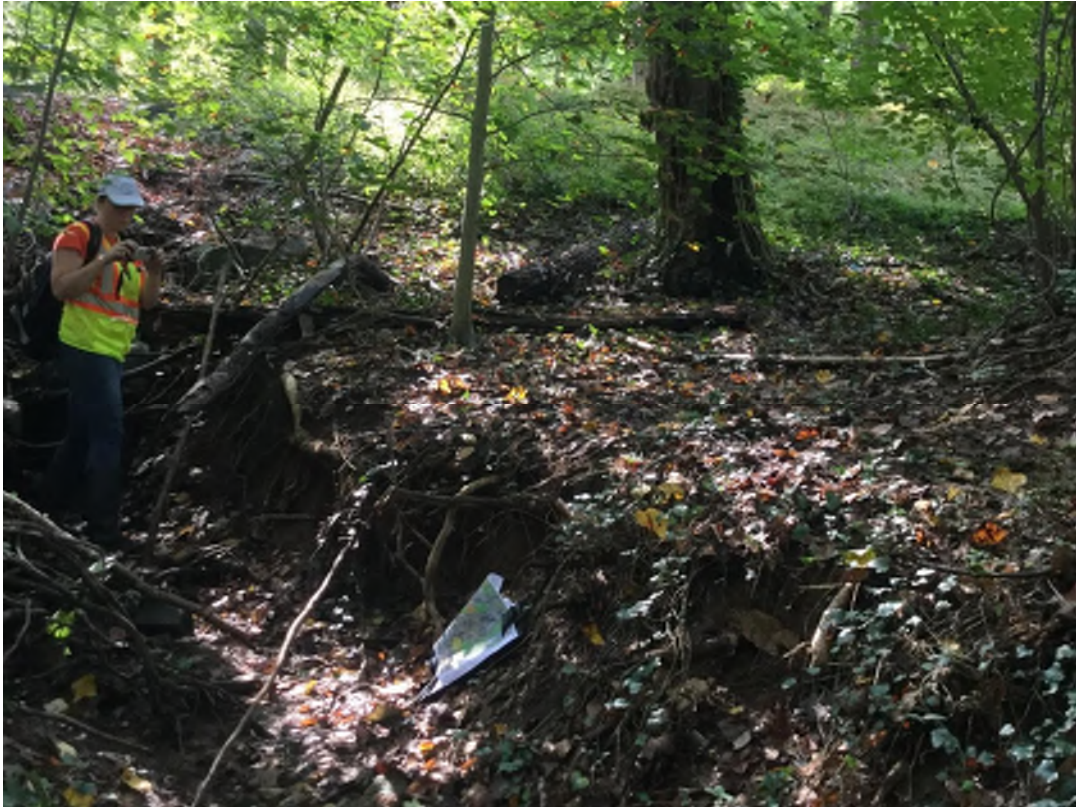
Figure 23: Bank erosion along tributary 4.

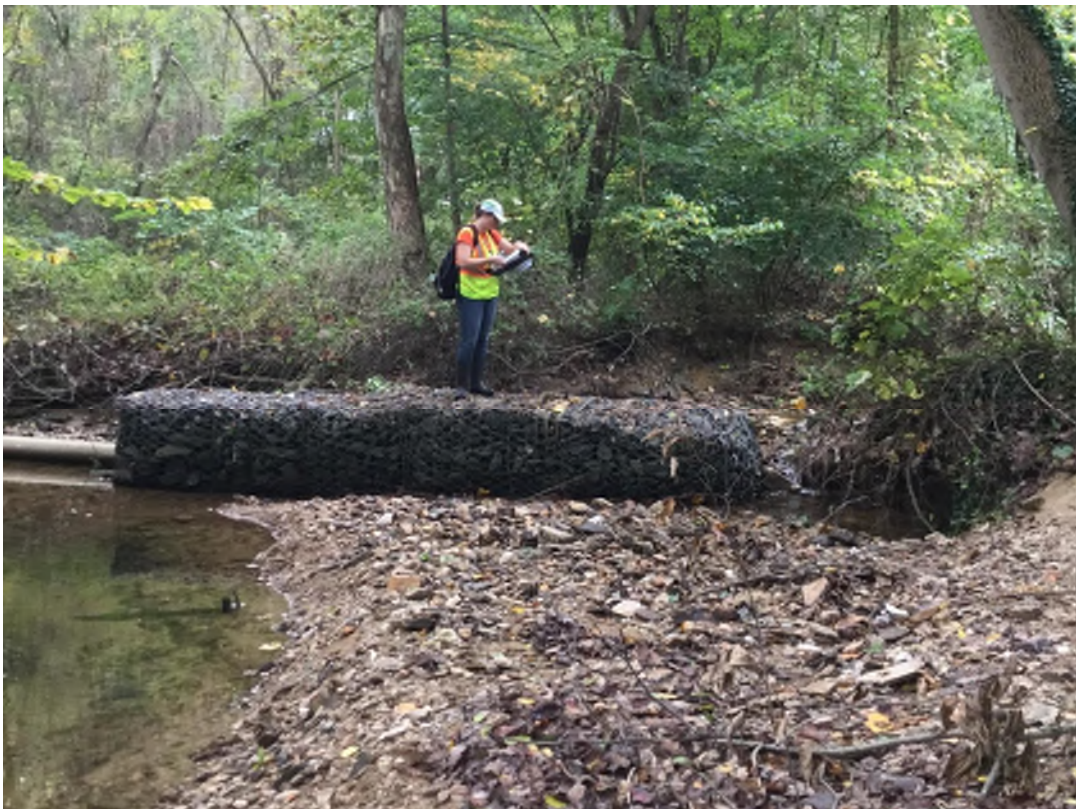
Figure 24: Existing fish barrier at confluence of tributary 1 with mainstem. Barrier is too high for fish passage.

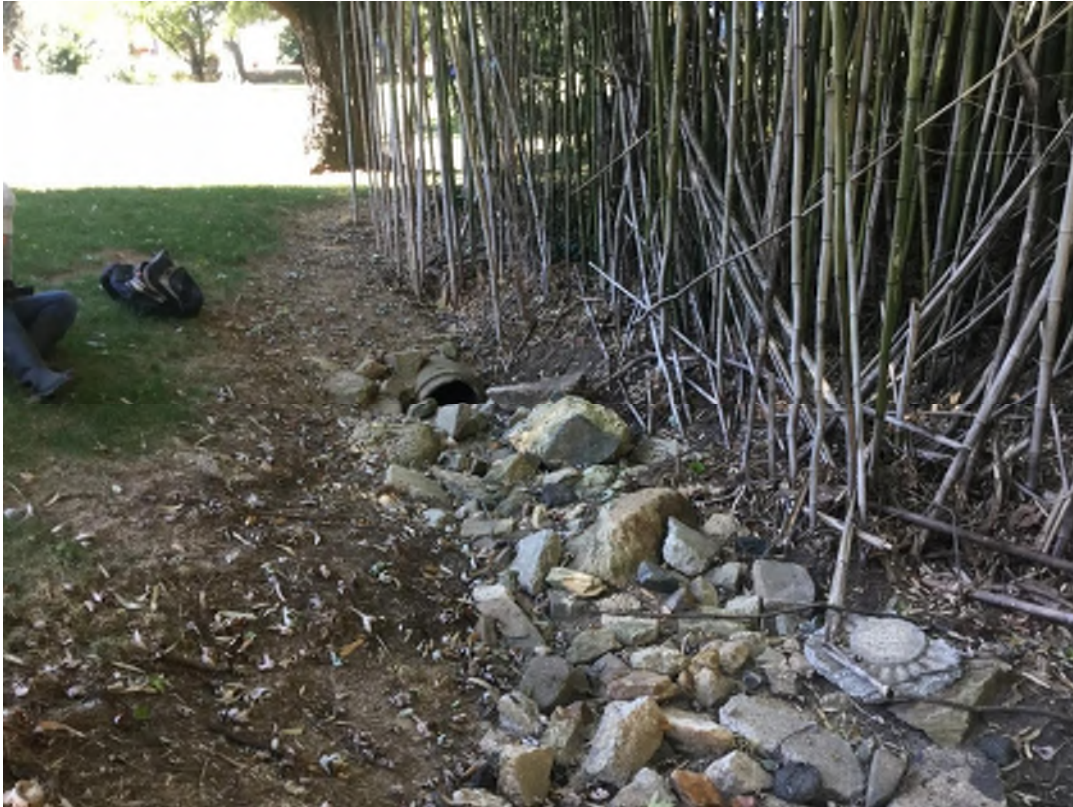
Figure 1: Outfall 37 is an 18-inch concrete pipe at the headwaters of tributary 2. Outfall is approximately 114 feet from the stream and has a 90-foot riprap outfall protection channel.

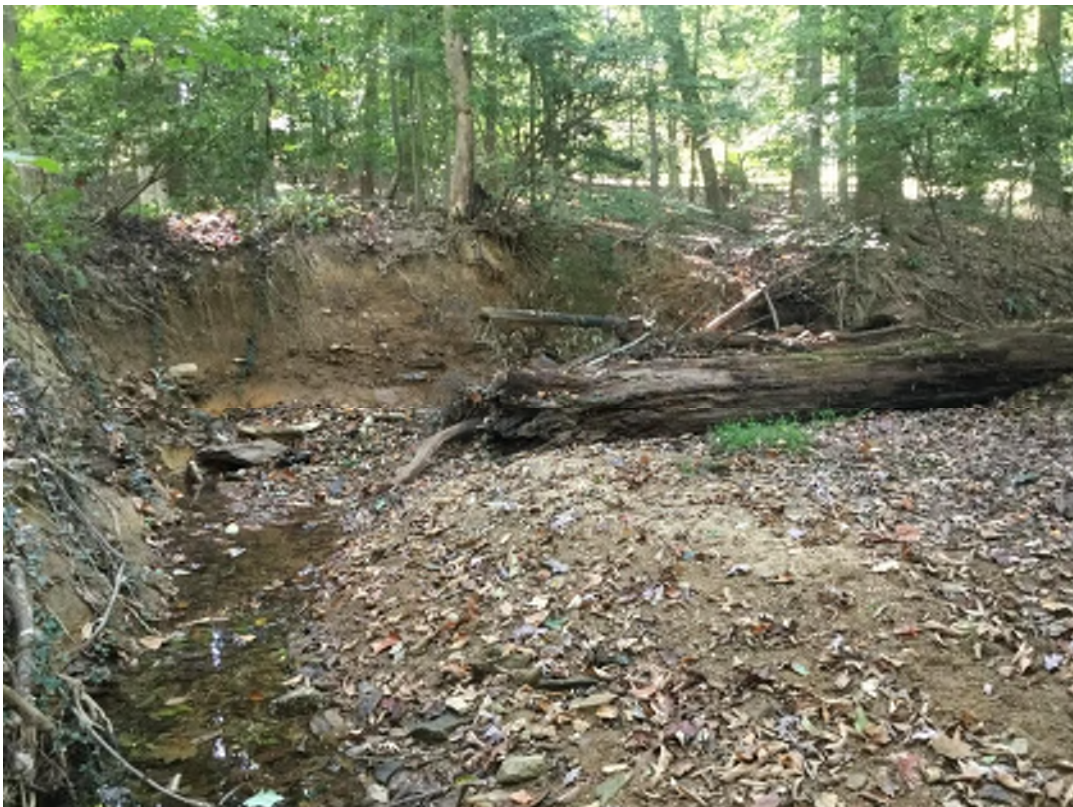
Figure 2: Bank erosion in tributary 2.

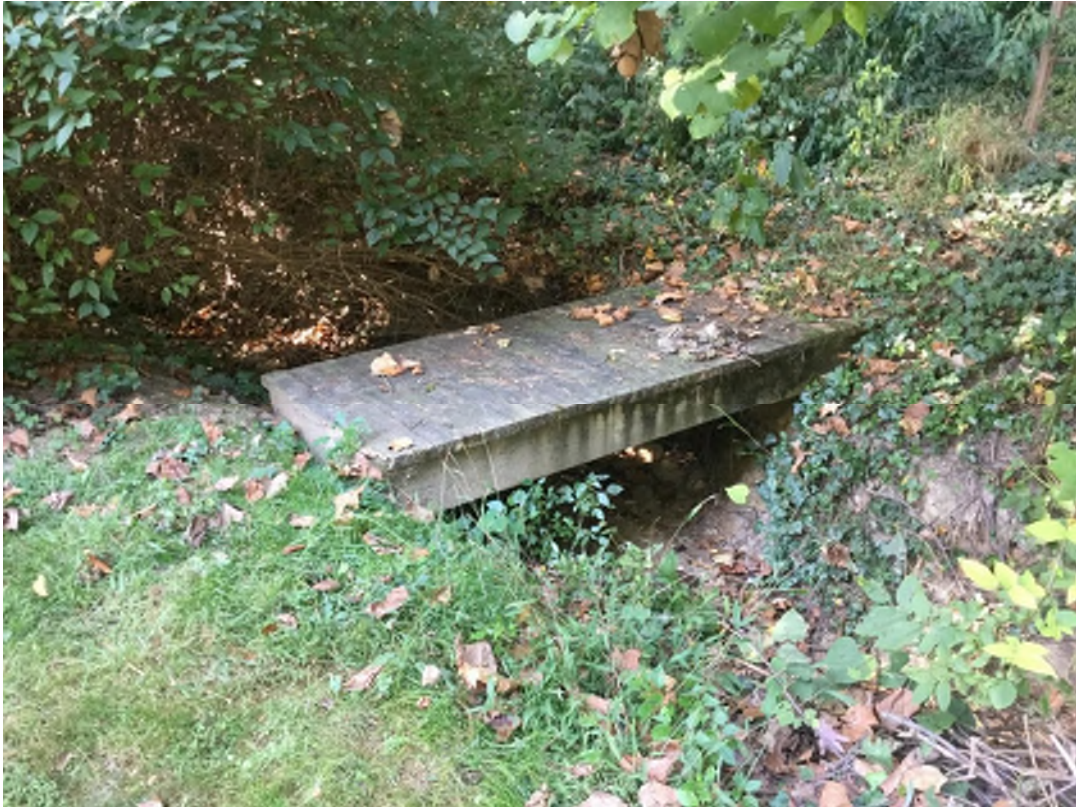
Figure 3: Wooden footbridge across tributary 2. Private backyard goes to edge of stream and to footbridge.

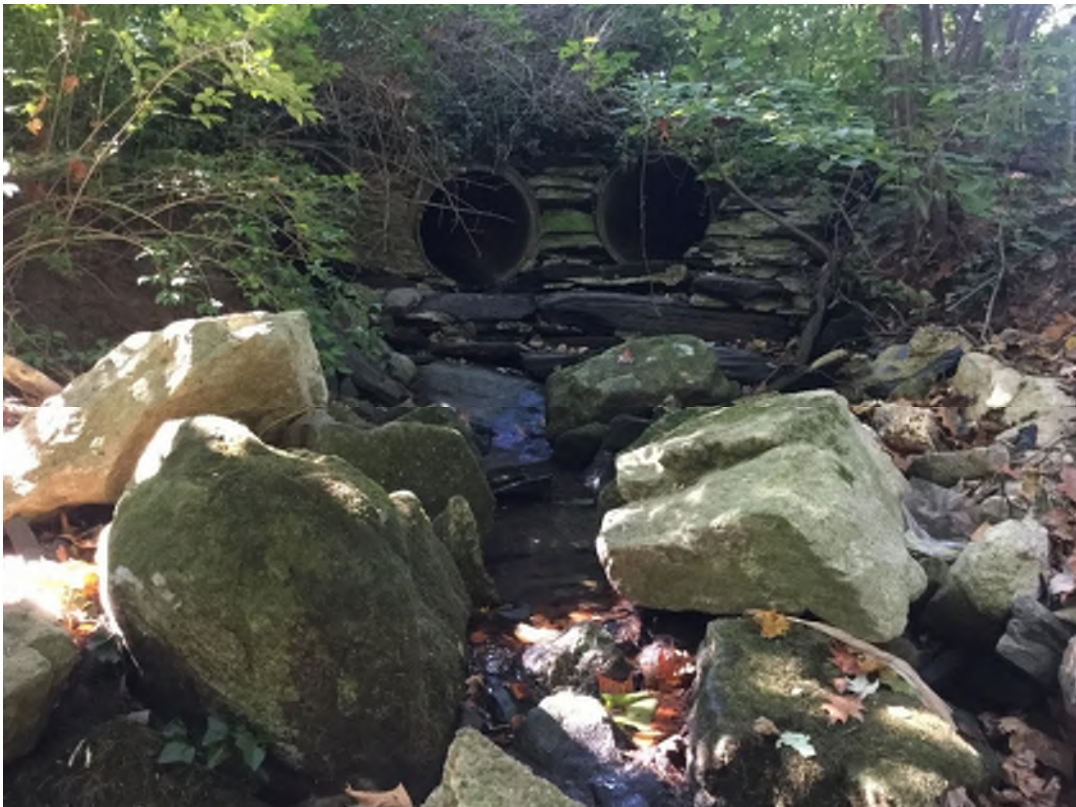
Figure 6: Outfall 24 is two pipes at the headwaters of tributary 1. Outfall is approximately 74 to stream with 19-foot riprap outfall channel protection.

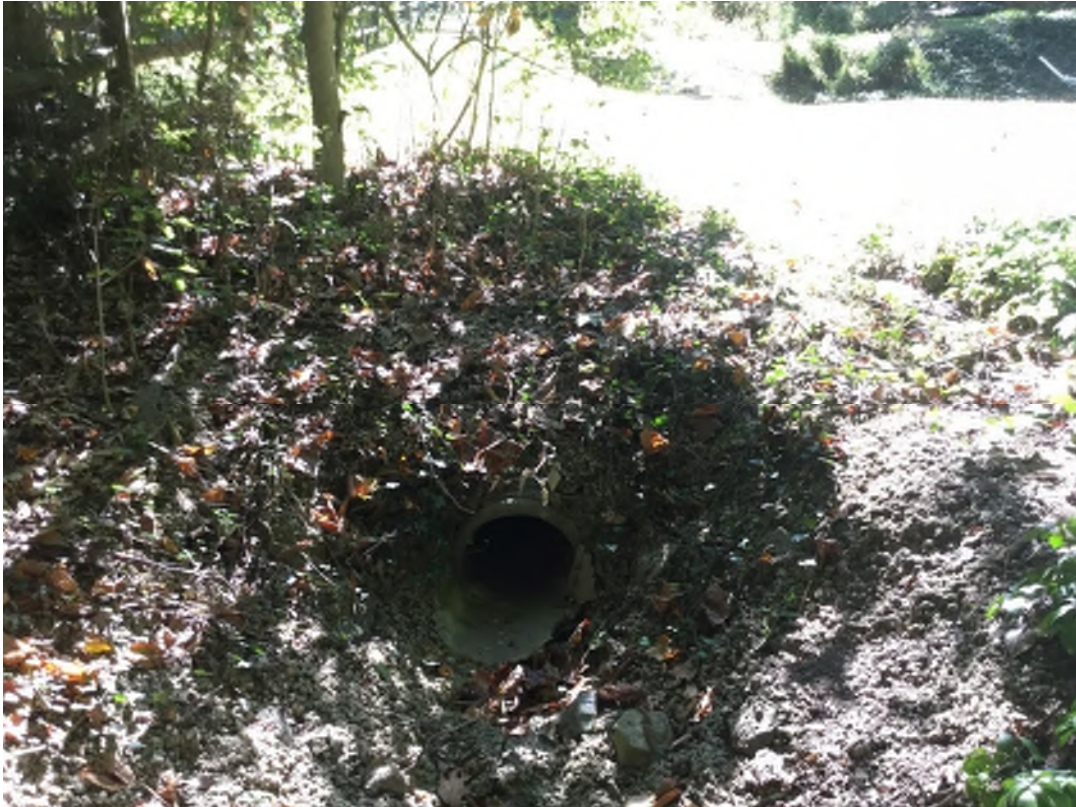
Figure 7: Outfall 25 is a 12-inch concrete pipe conveying flow to the right bank of tributary 1. Outfall is approximately 23 feet from stream. Entire distance to stream is concrete channel outfall protection.

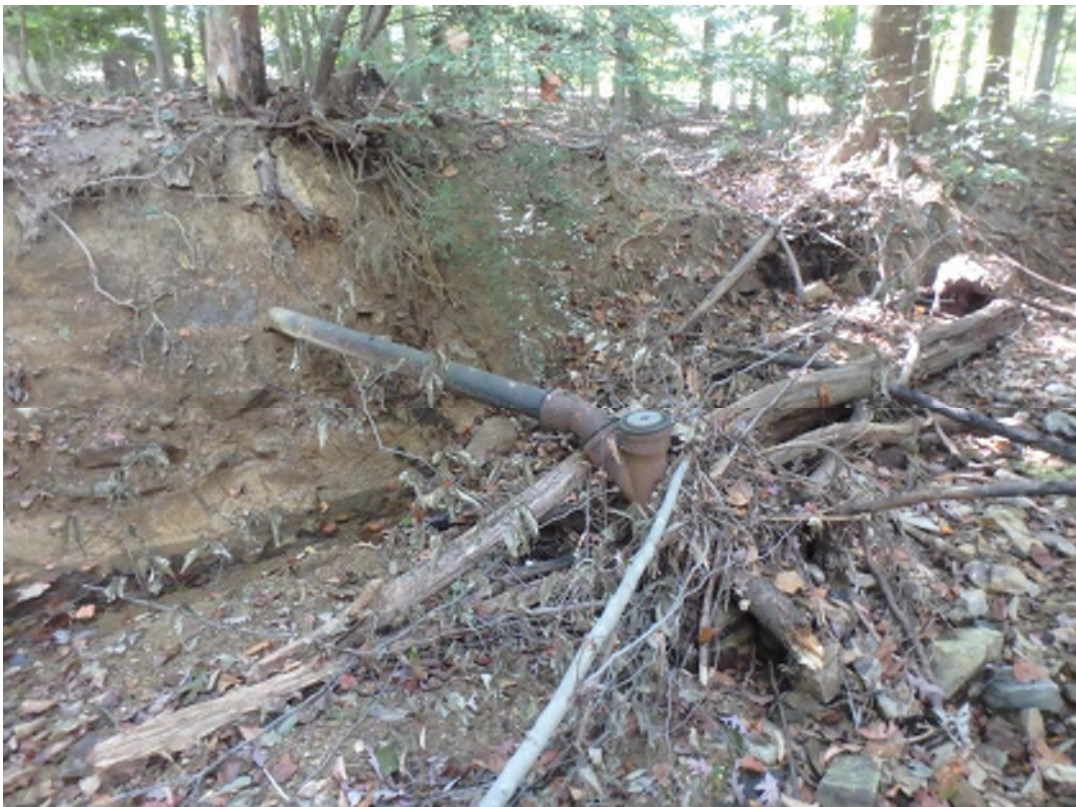
Figure 8: Exposed pipe extended from right bank to stream bottom in tributary 1. Pipe is approximately 9 feet long. The purpose of the pipe is unknown.

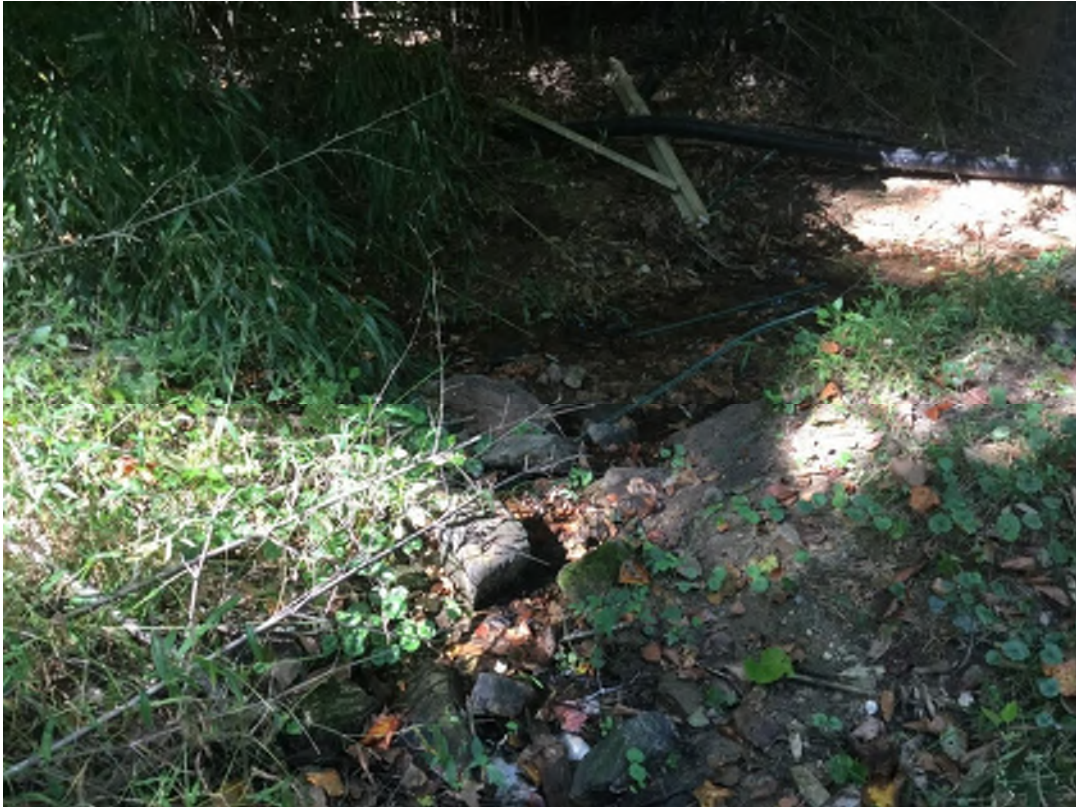
Figure 9: Natural spring to right of tributary 1. Confluence of natural spring with tributary 1 on right bank.

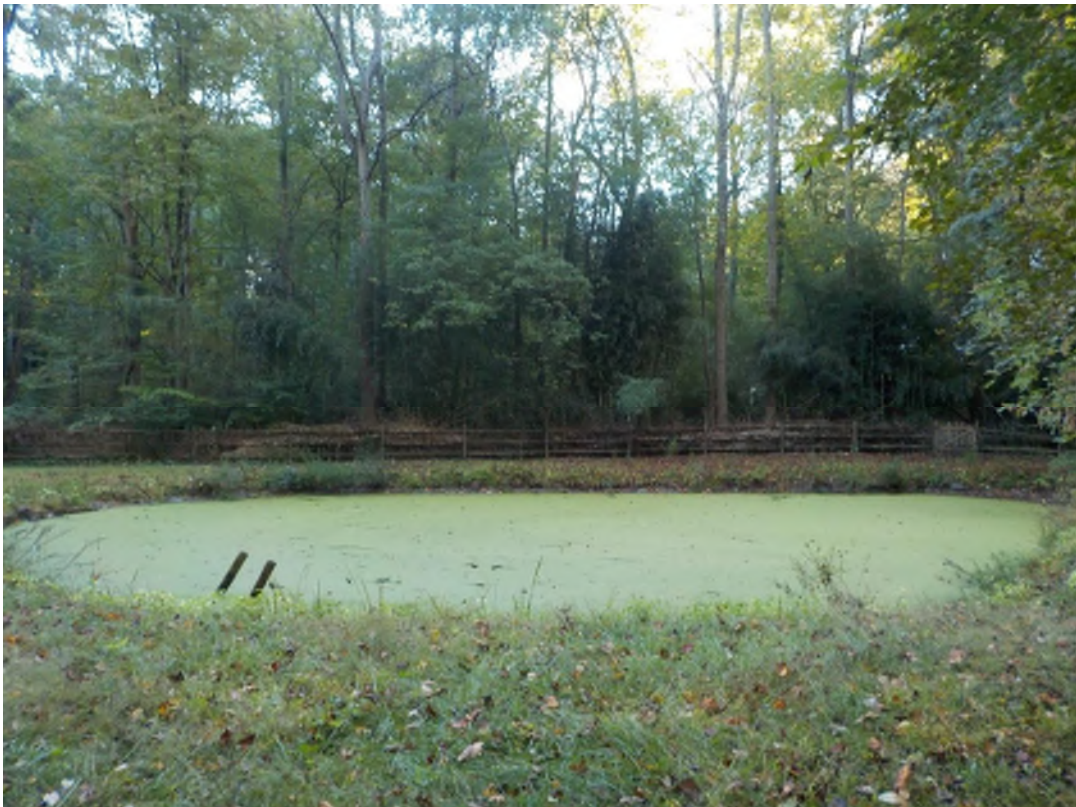
Figure 10: Existing pond adjacent to tributary 1 on private property. Overflow from pond enters stream.

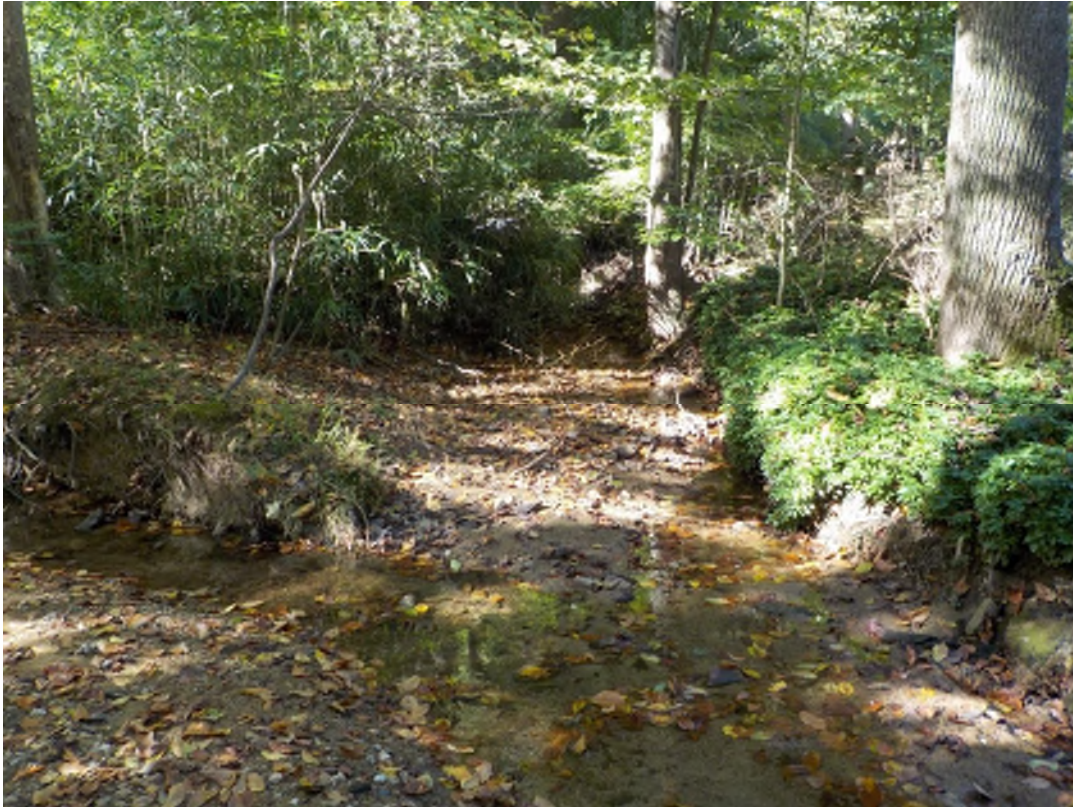
Figure 11: Confluence of tributary 1 (right) and mainstem (left).

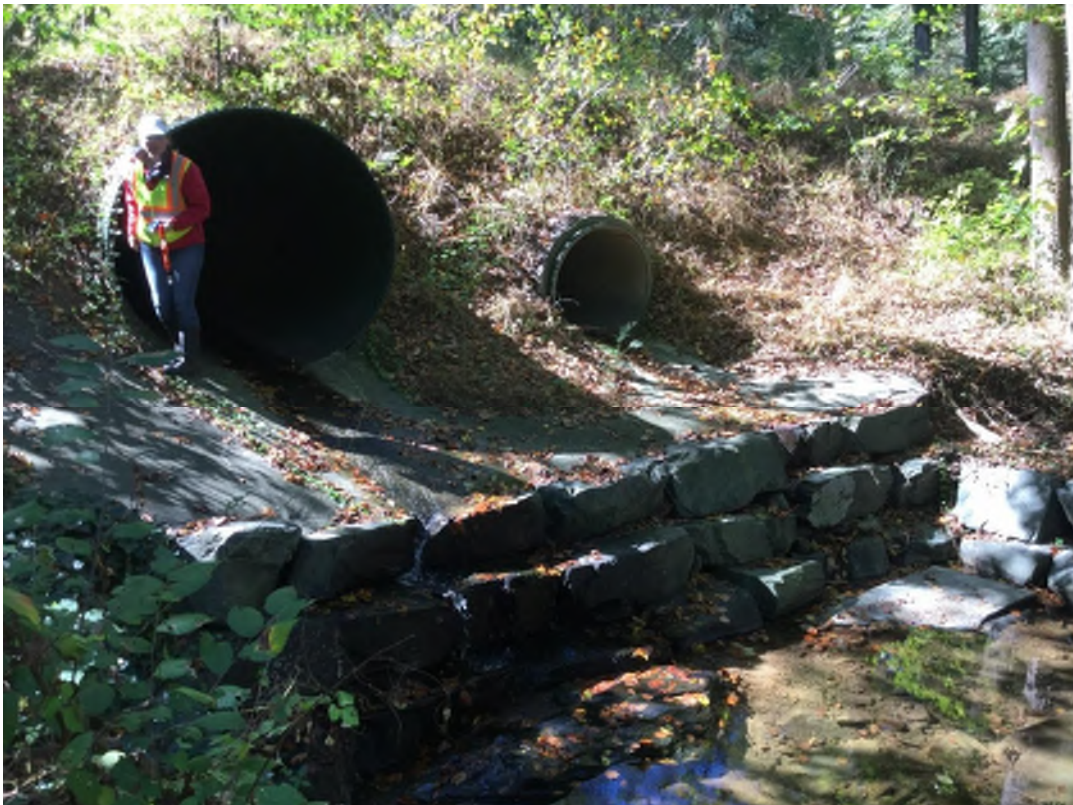
Figure 12: Culvert under Carolina Avenue in mainstem. Culvert on left in photo is a 78-inch cast iron pipe that conveys most the flow. Culvert on right in photo is a 48-inch reinforced concrete pipe. Flow exits culverts to concrete outfall protection and flows a 4-foot drop over pictured rock sill.

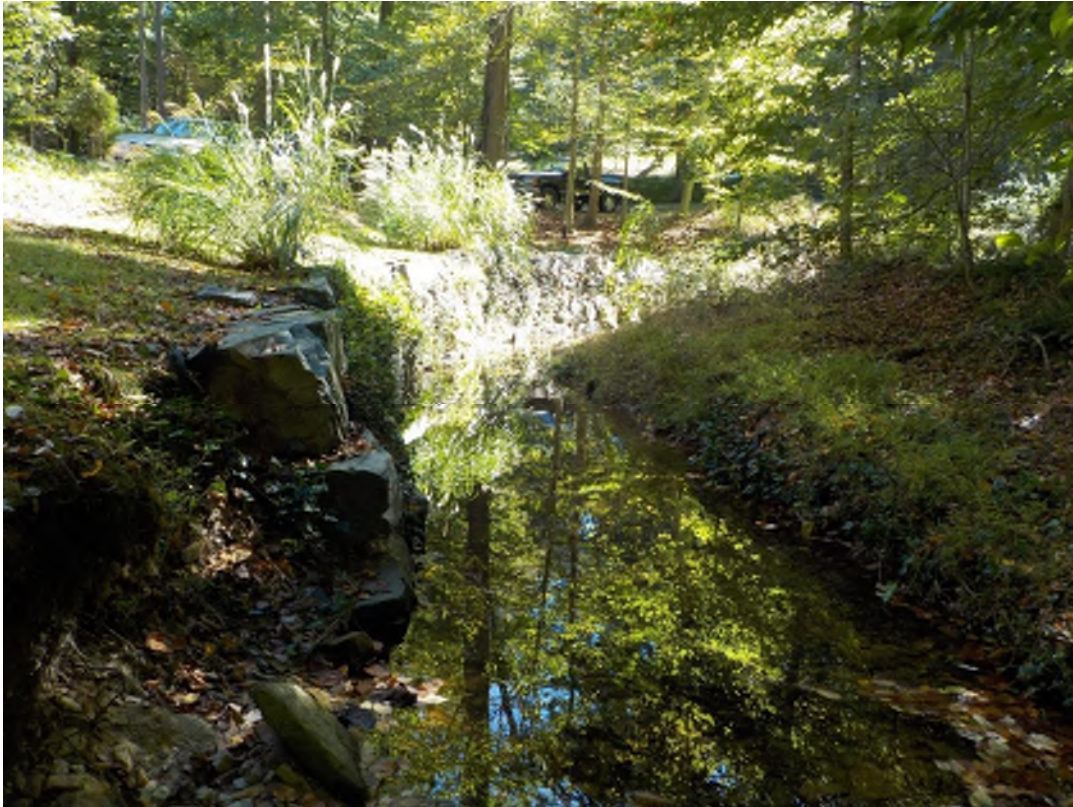
Figure 13: Looking upstream at channel alteration of mainstem just downstream of Carolina Avenue culvert (Figure 12). Right bank armored with stone boulders for approximately 86 feet in mainstem.

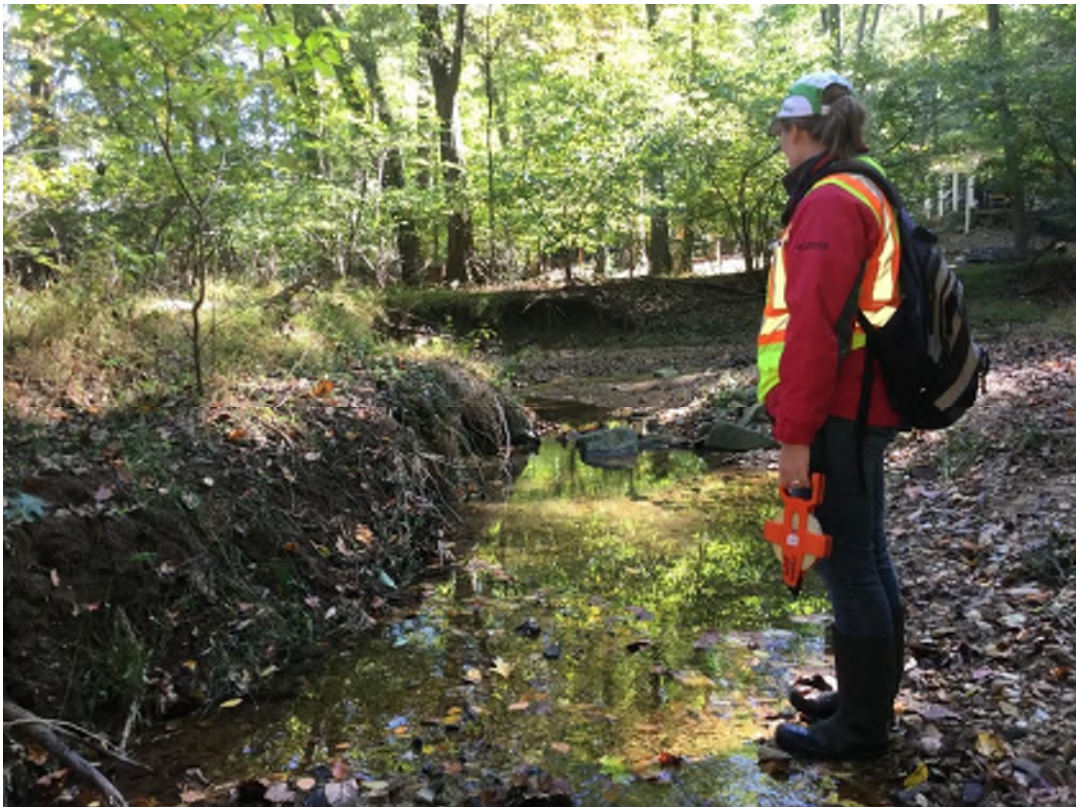
Figure 16: Bank erosion in mainstem.

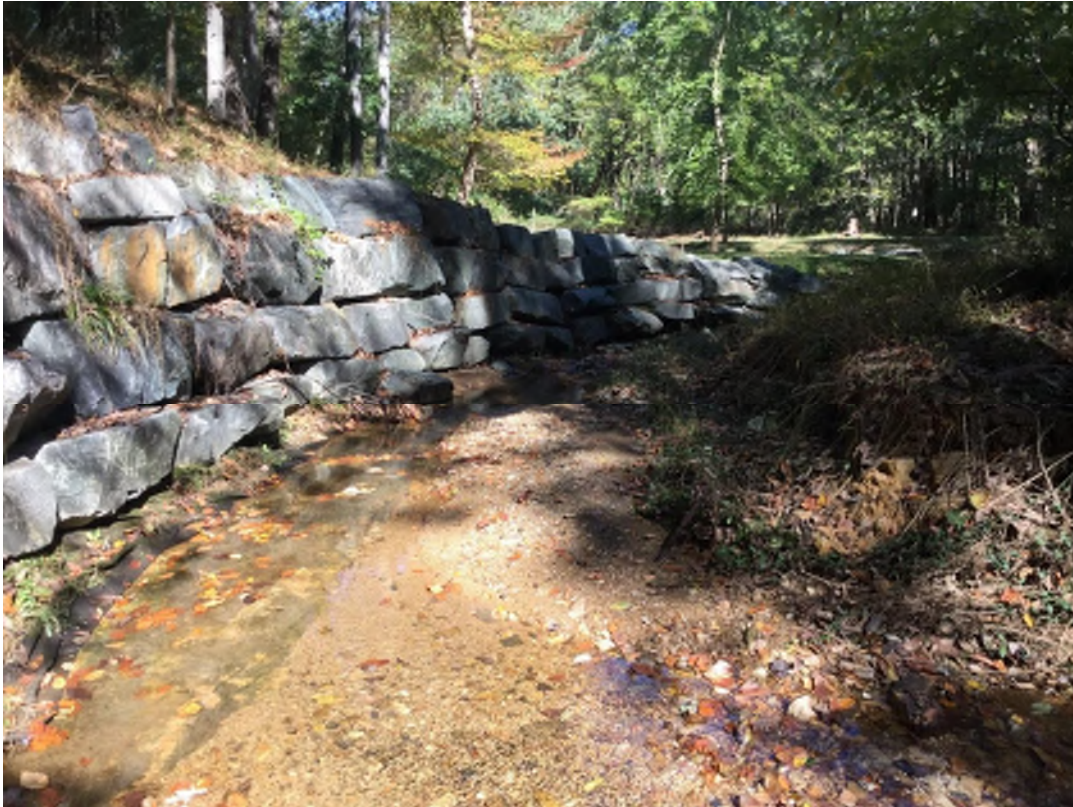
Figure 17: Channel alteration in mainstem. Left bank armored with approximately 180 feet of stone boulders.

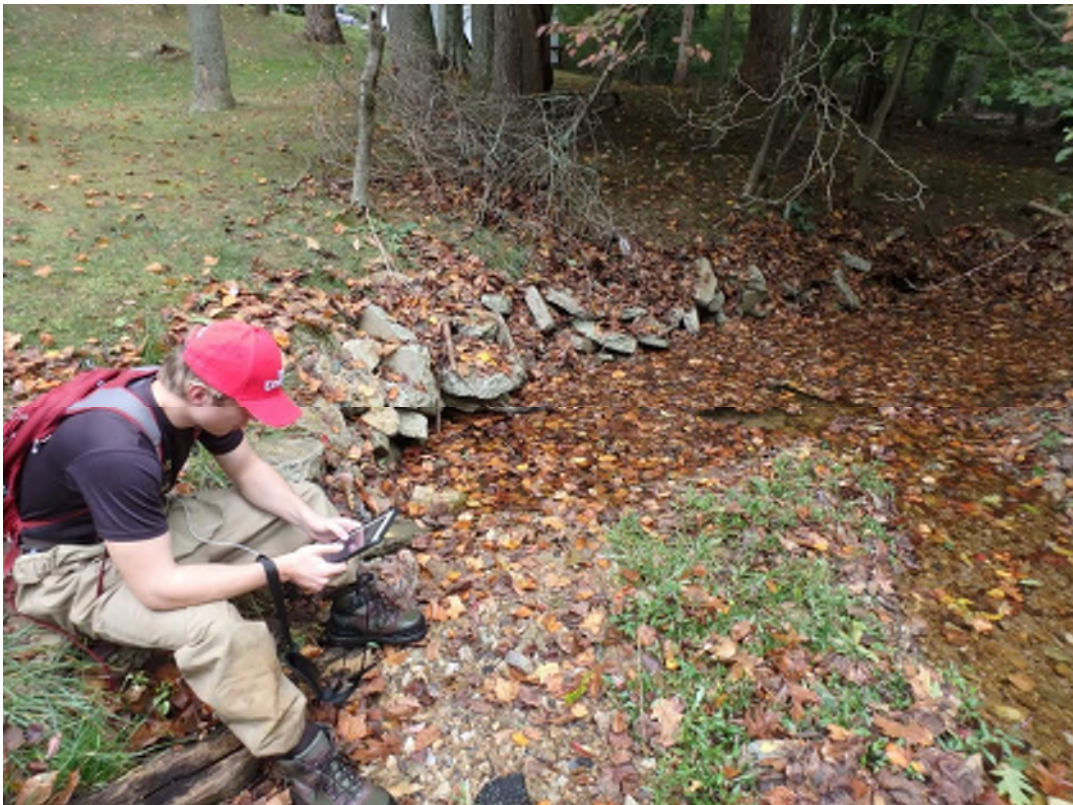
Figure 18: Channel alteration in mainstem prior to confluence with tributary 3. Left bank armored with approximately 58 feet of riprap.

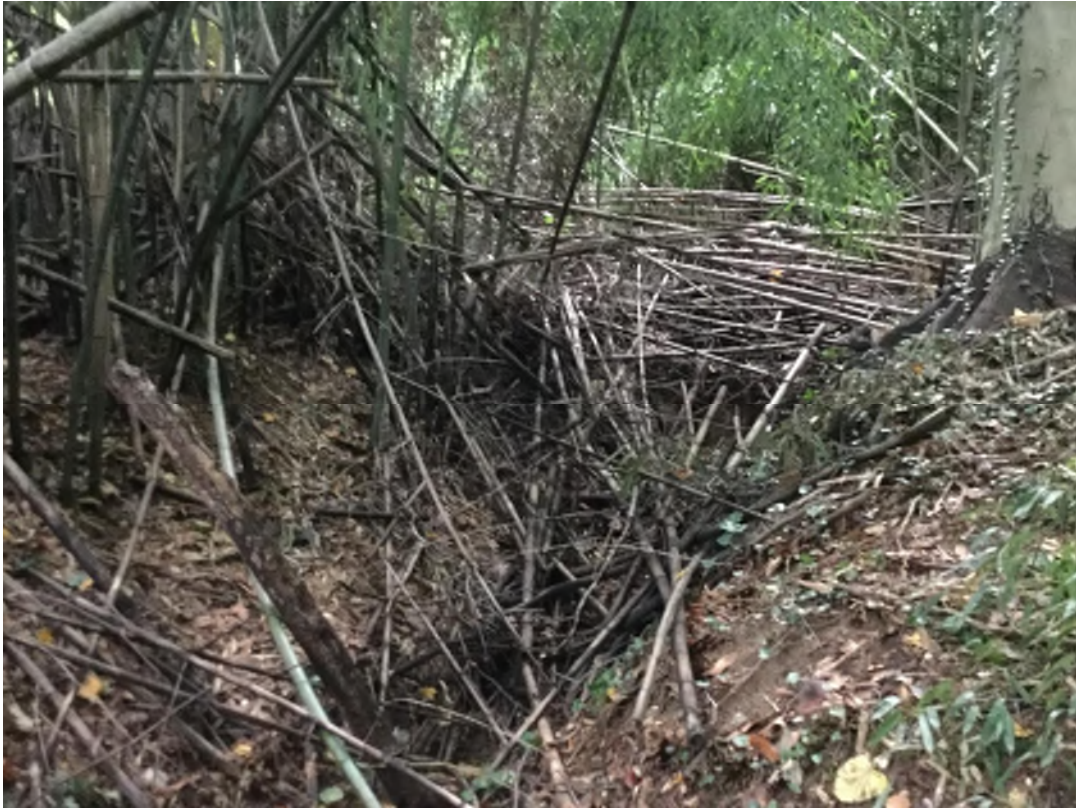
Figure 19: Inflow at headwaters of tributary 3.

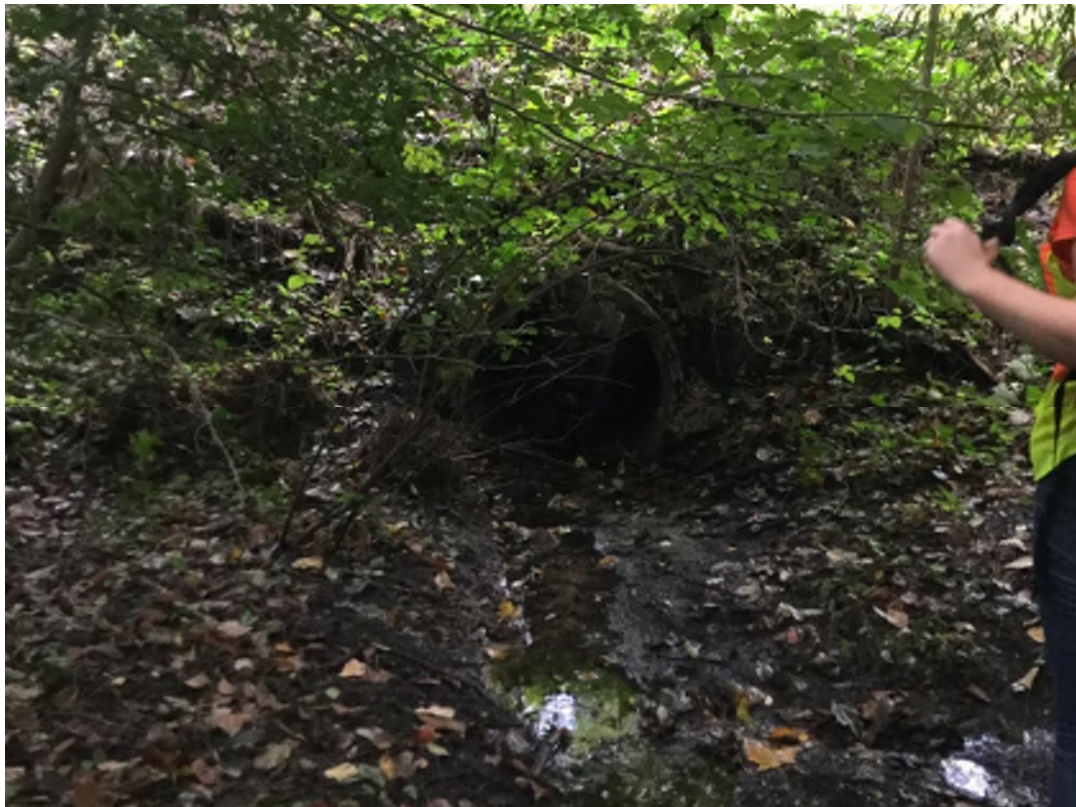
Figure 20: 36-inch culvert conveys flow under Spring Drive in tributary 3.

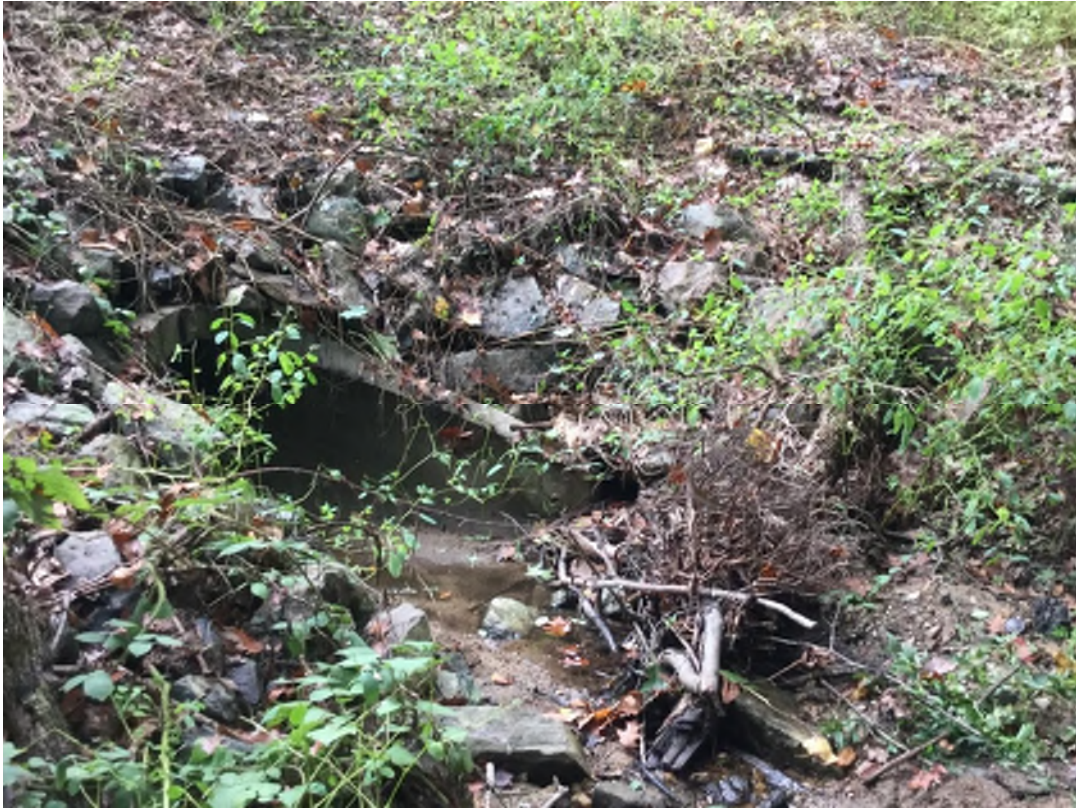
Figure 21: Culvert conveys flow under Dixie Drive in tributary 3. Culvert is a 36-inch reinforced concrete pipe with 13 feet of outfall protection.

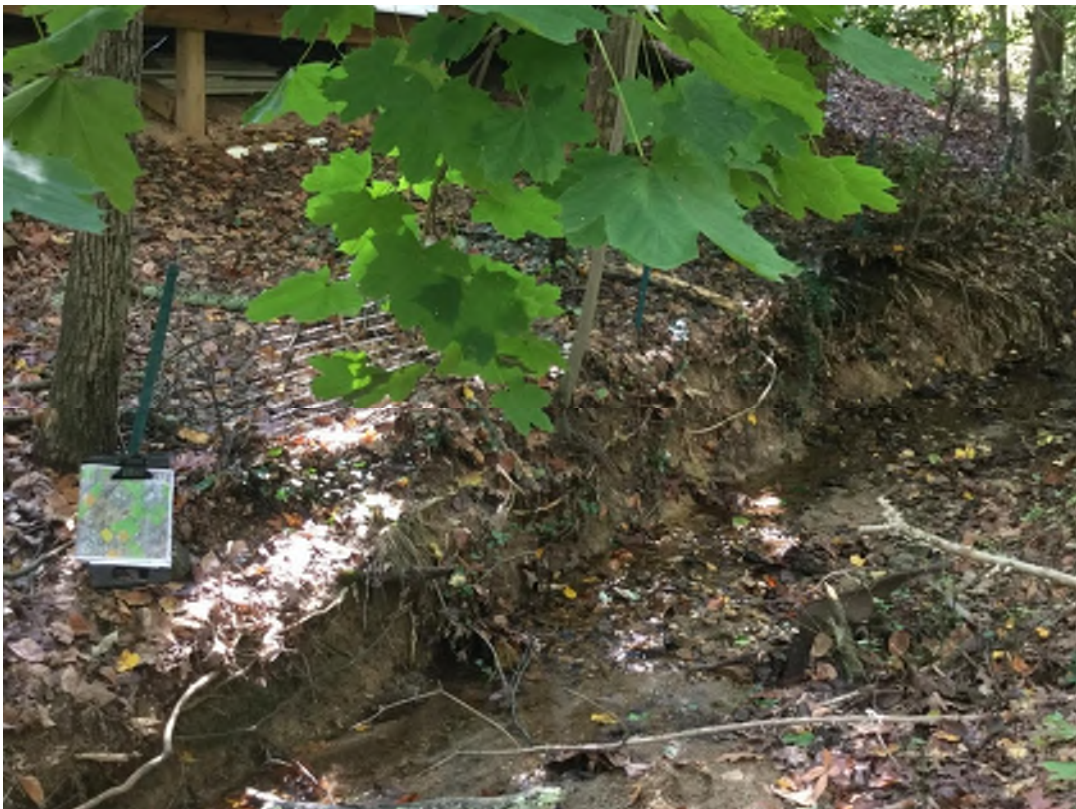
Figure 22: Bank erosion in tributary 3
